Gary Whitesides
Gala Construction
2215 Plaza Dr ste 100
Rocklin, CA 95765
Re: The Retreat
Walnut Creek, CA

12/15/2010

Over the course of the last several weeks my office has made two visits to The Retreat Apartments, formerly known as Whispering Oaks. Based on those visits and our discussions, we would like to share some of our observations and opinions with you regarding key areas of the project site:

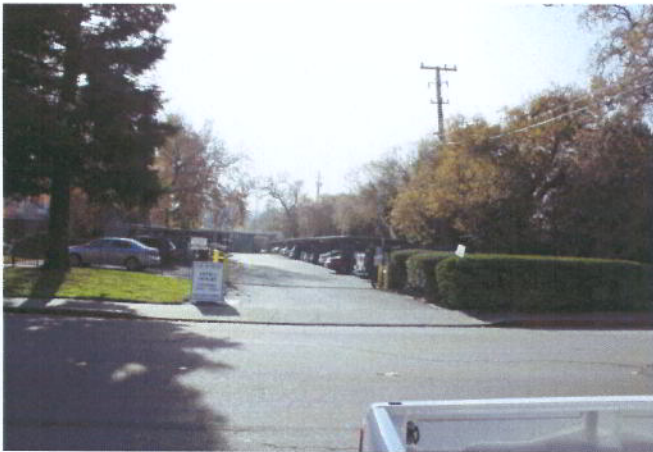
- The entry from the street into the parking lot needs to be enhanced and emphasized (see photo 1.)
Design solutions might include:
 - A more architectural gate.

Photo 1 - View at main entry.

- Flanking masonry pilasters.
 - Well-placed signage.
 - Replacement of the hedges and lawn adjacent to the entry with flanking specimen planting.
 - Water feature.

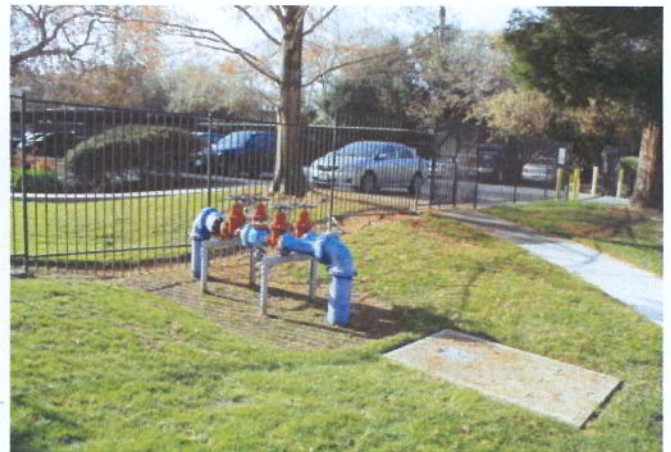
- The backflow prevention device should be screened from view (see photo 2.)
- Carports are flimsy in appearance and in poor repair (see photo 3.)
- Several trees are failing trees and should be replaced. Lawn and plant treatments requiring regular irrigation should be pulled away from oaks.

Photo 2 - Backflow device at entry.

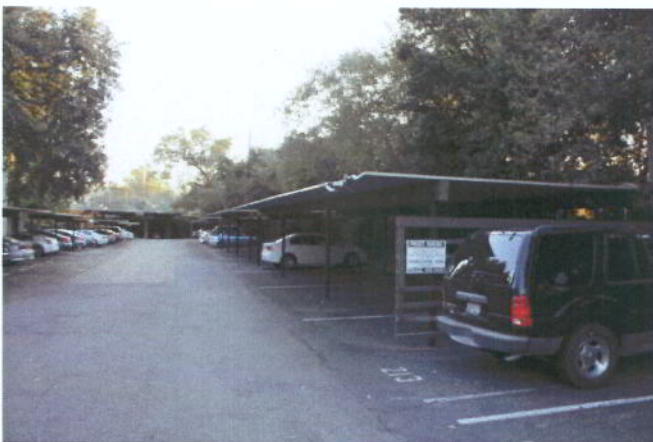
Photo 3 - Carports in poor repair.

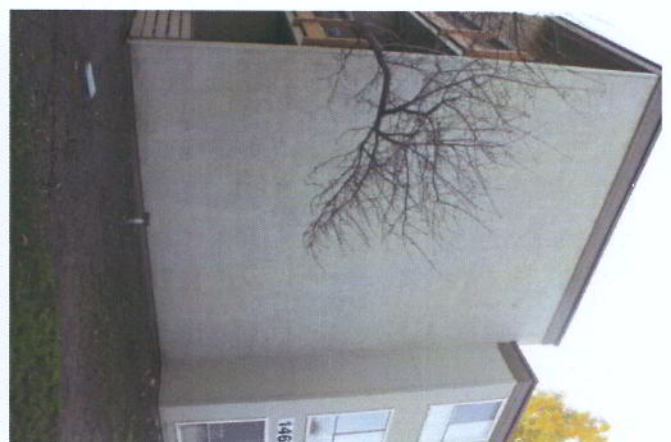
- Additional tree plantings should be provided to filter views of the buildings (see photo 4.).
- Failing timbers in the dog lawn area should be replaced, perhaps with boulders and planted slopes (see photo 5.)

Photo 4 - Exposed building wall.

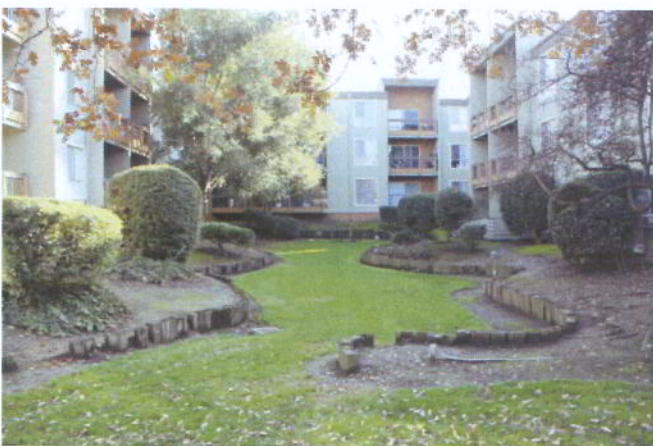
Photo 5 - Failing timbers at dog walk.

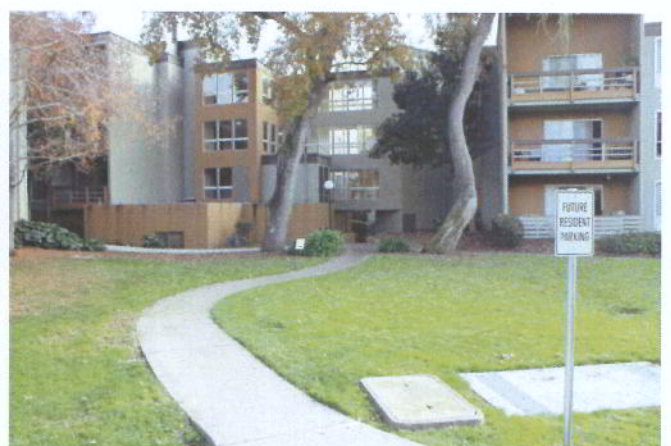
- The walkway from the guest parking to the Rental Office is narrow and meandering, and should be replaced with a wider and more direct approach (see photo 6.)

Photo 6 - Narrow, meandering entry walk.

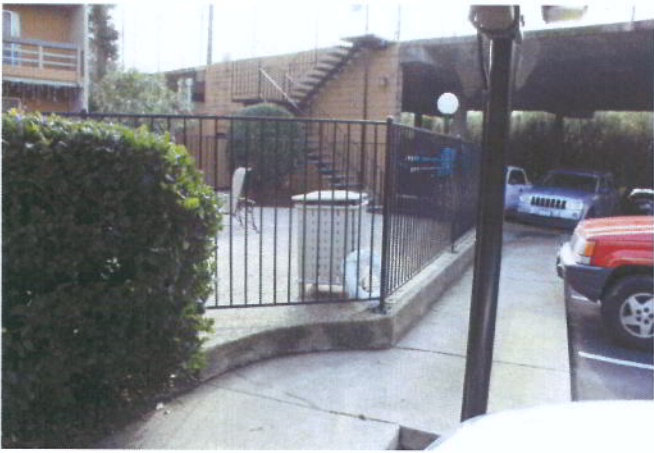
- The utility boxes should be screened from the Rental Office walkway.
- The spa area is uncomfortably proximate to the walkway, and screening should be provided or the spa moved to a more appropriate location (see photo 7.)

Photo 7 - Spa feature adjacent to rental office walkway.

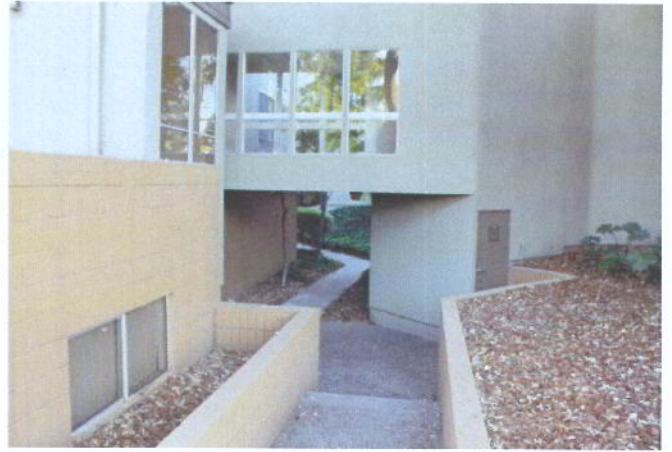
- The stairs down to the Rental Office landing are narrow and uninviting. Lower stepped planters alongside widened stairs, broken into two flights, would open up the approach (see photo 8.)

Photo 8 - Narrow, uninviting entry stairs.

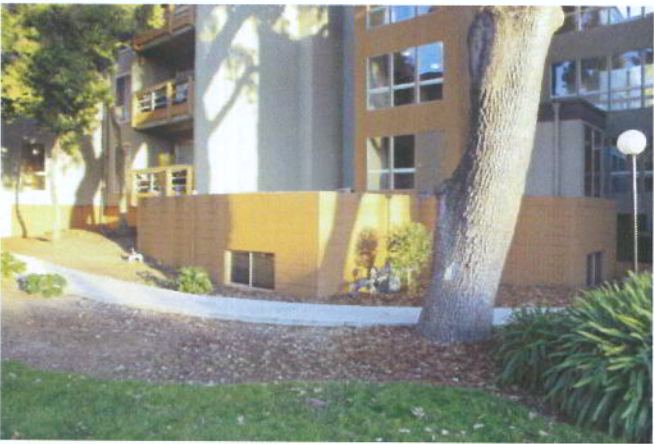
- The utility building to the left of the walkway is unattractive and should be screened (see photo 9.)
Rerouting the side walkway would provide more space for screening plant materials.

Photo 9 - Unattractive utility building at rental office walkway.

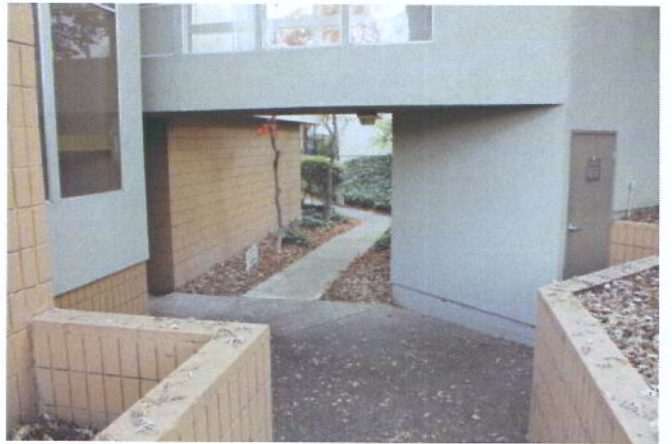
- The cameo view through the walkway to the pool area is significant, and could be improved by providing a curving walkway and specimen plantings with low retaining at the toe of slope. The hanging light fixture is distracting and should be replaced (see photo 10.)

Photo 10 - Cameo view/walkway to pool area with light fixture.

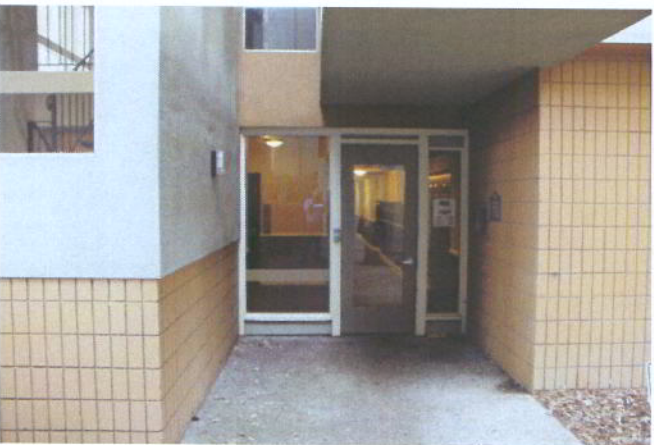
- The narrow gap between buildings creates an uncomfortable 'canyon' of space, which could be mitigated by use of light metal trellage overhead (see photo 11.)

Photo 11 - Narrow 'canyons' of space.

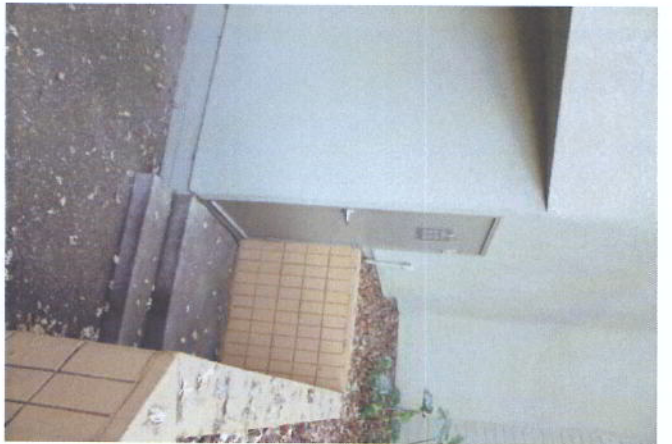
- The doors into the apartments have a utilitarian appearance, and could be enhanced by trim, expanded walkways and landings and/or use of porch roofs (see photo 12.)

Photo 12 - Apartment entries.

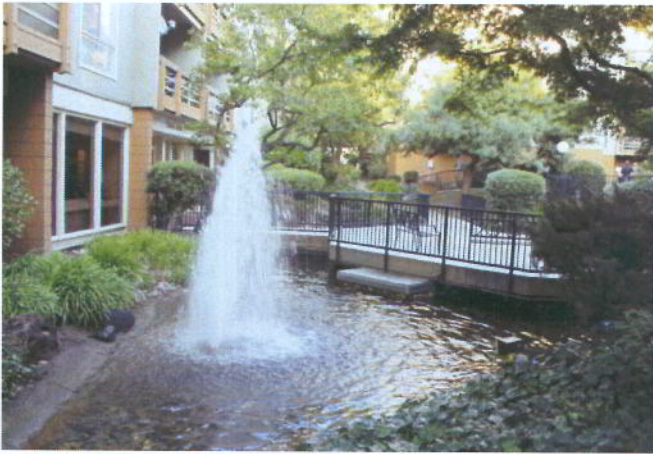
- The fountain feature is oppressive in its sound and volume. A spray head with less volume and a more attractive arc could enhance the space (see photo 13.)

Photo 13 - Fountain outside gym entrance.

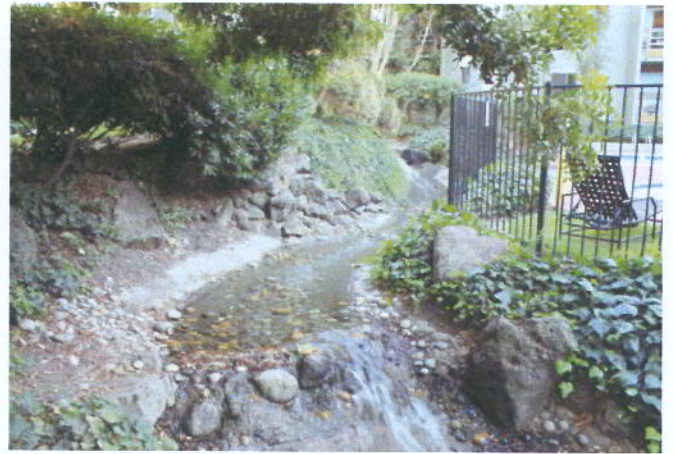
- The recirculating water course is similarly oppressive in its unbroken, high-volume flow. The feature could be enhanced by slowing the flow and breaking it into a series of still pools and ripples (see photo 14.)

Photo 14 - Watercourse with unvaried flow.

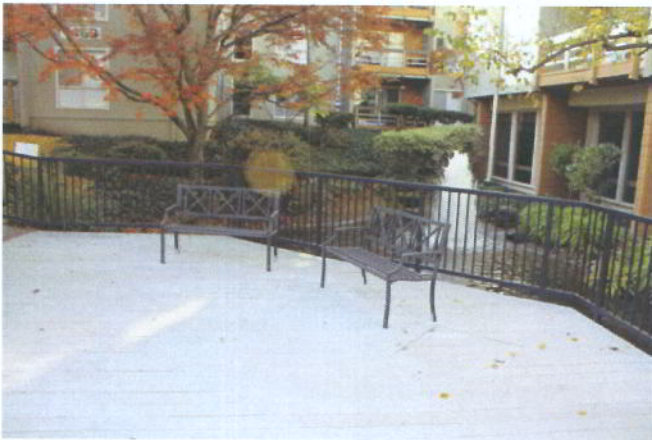
- The benches on the deck should be realigned to better relate to the lines of the decking and buildings. Planters could further enhance the deck space (see photo 15.)

Photo 15 - Poorly placed benches, brightly toned decking.

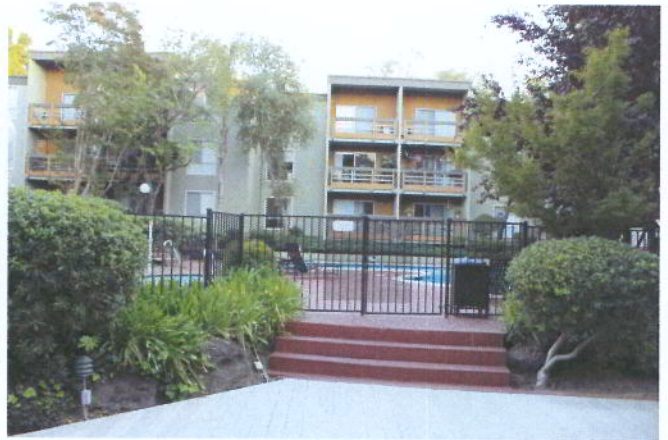
- The pool perimeter fencing follows some erratic and distracting lines and could be realigned to provide space for additional features.
- The connection between the pool area and the lower deck area could be strengthened with wider and more direct stairs. (see photo 16.)

Photo 16 - Entry to pool could be enhanced.

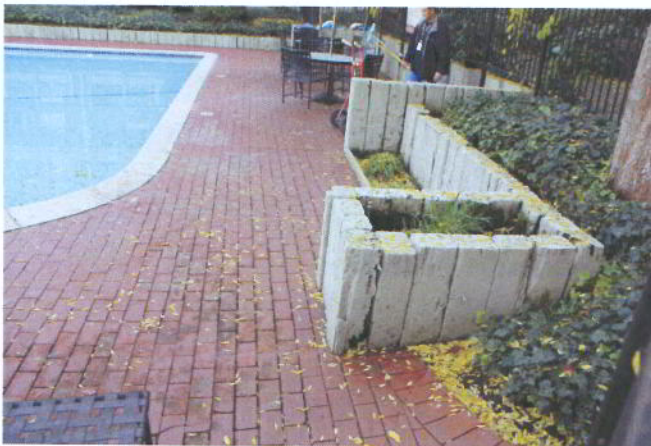
- The vertical landscape timbers used as retaining are failing and should be replaced (see photo 17.)
- Portions of the sidewalks are uncomfortably steep and potentially hazardous, and should be reconfigured to provide gentler grades or replaced with steps.

Photo 17 - Failing retaining and planters at pool.

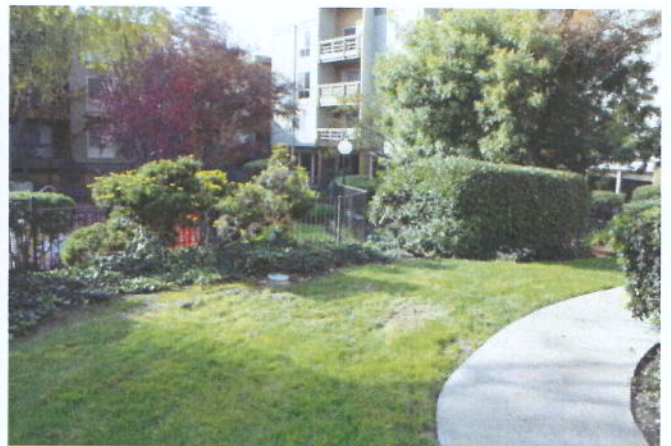
- The lawn area above the pool could provide the opportunity for a barbecue patio and outdoor entertainment space outside of the confines of the pool area (see photo 18.)

Photo 18 - Lawn area above pool could be better utilized.

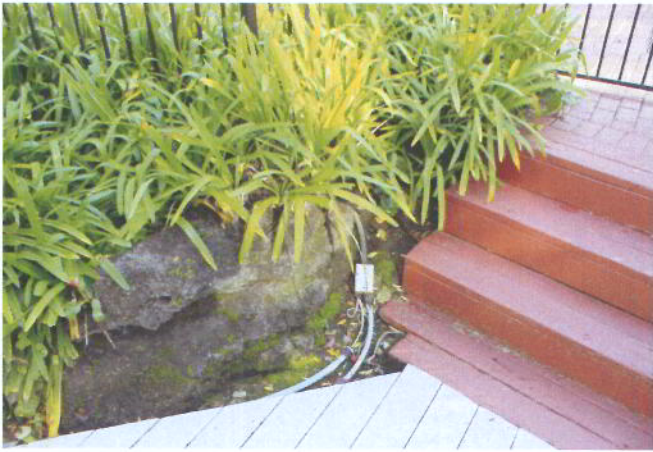
- The coarse chipped bark is unattractive and difficult to keep in place.
- The electrical conduit is unattractive and cable is exposed in places, creating a hazardous condition (see photo 19.)

Photo 19 - Conduit with exposed wiring.

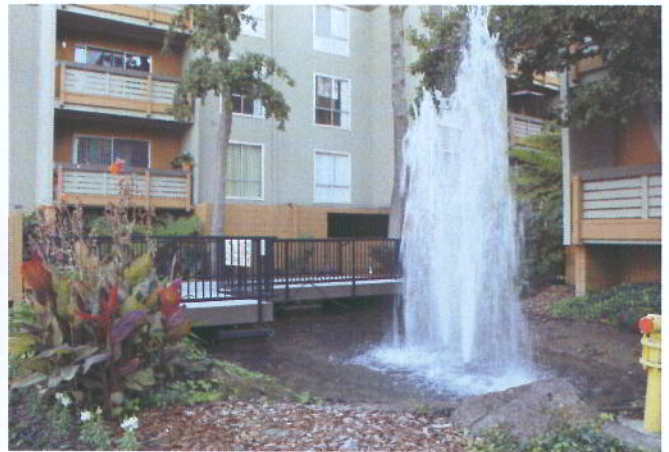
- The fountain feature would benefit from less volume and more attractive arcs.
- Two fountains seems an excessive treatment for a minor entry (see photo 20.)
- The sand treatment on the sidewalls of the water course does not work.
- The exposed rims of the pools are unattractive, and should be concealed with soil, boulders and planting (see photo 21.)
- The use of annual flowering plantings along the street requires considerable maintenance and provides little visual impact (see photo 22.)
- Much of the lawn area along the street could be replaced with more attractive groundcovers which would reduce maintenance and irrigation costs.

Photo 20 - High volume fountains at pedestrian entry.

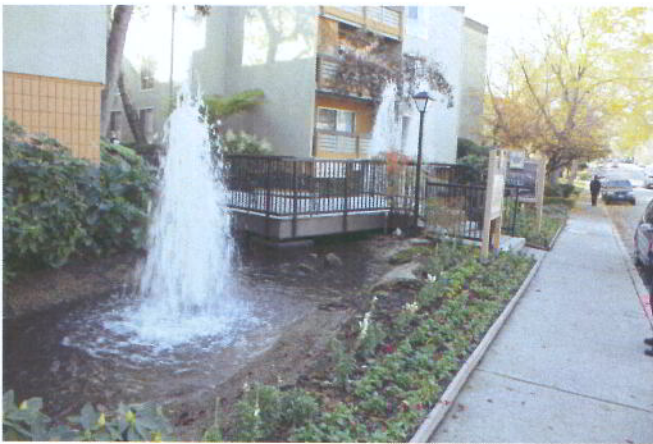
Photo 21 - Exposed rim of fountain pool.

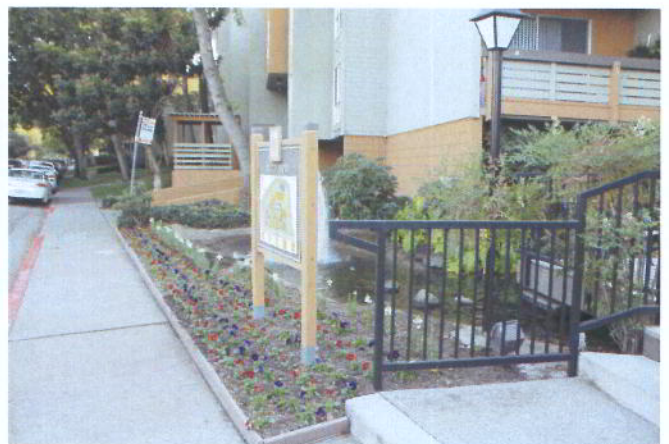
Photo 22 - Annuals at entry with poor header.
