CLOSURE AND
RECLAMATION PLAN FOR
BLUE POINT MINE

CA MINE ID #91-58-0021

Brian Bisnett, asla, aicp
Bisnett Design Associates
7/1/2005

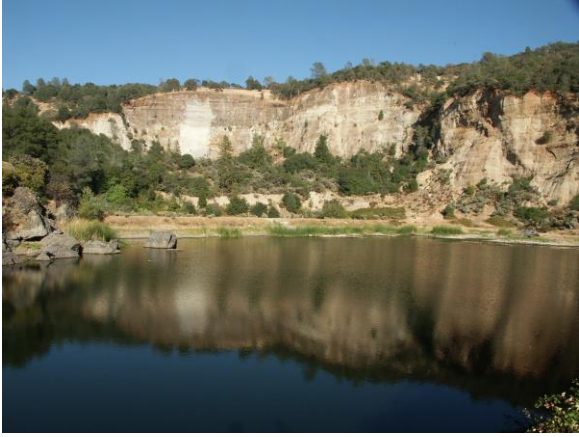
Photo 1 – Upper Ponds (Three)

Three ponds, two of which appear to have been of post-SMARA construction, are fed by groundwater, and contribute to the biotic and aesthetic attributes of the site (see photo 1, following page) These ponds do not receive significant surface run-off, and show minor evidence of sedimentation. Downstream, two detention basins (see photo 2 following page) that likewise receive little surface run-off hold water only seasonally, though are developing vegetation indicative of perennially moist soils and also appear to be contributing significantly to the biotic attributes of the site

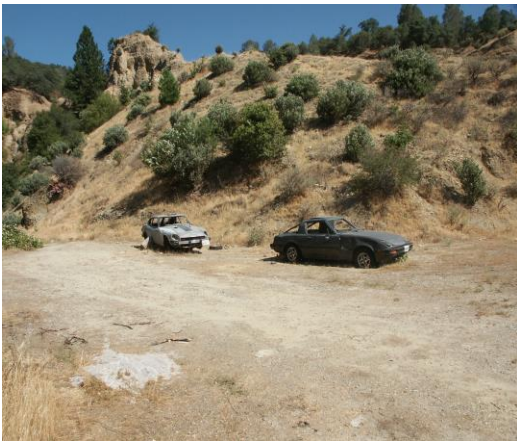
Photo 1 – wrecked cars

The abandoned vehicles, scrap metal and trash on site, and much of the mining equipment, have been removed.

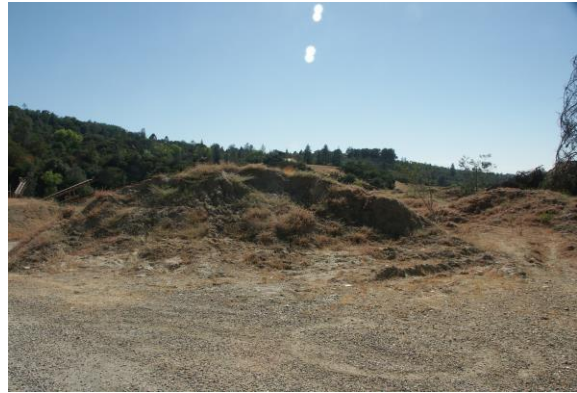
Photo 6 – sand stockpile

1. Sizing of the culvert is specified as 24" per the rational method as calculated in Appendix X :
- iv. The stockpiled sand piles will be spread over the site as topdressing over scarified soils, to improve soil texture and aid in germination.

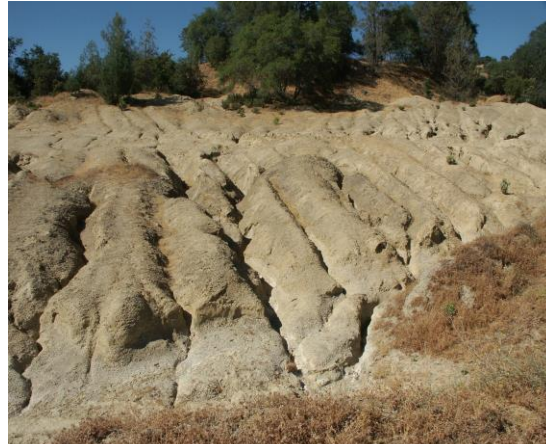
Photo 12 – eroding sand stockpiles

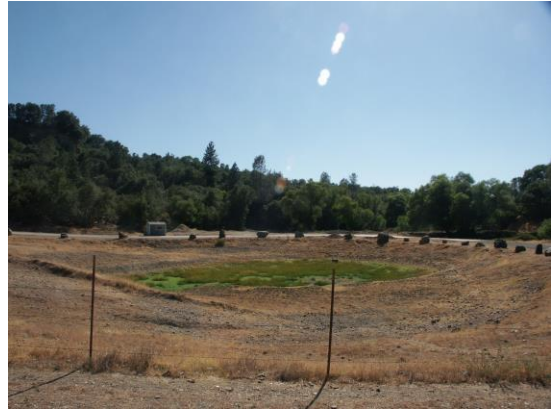
Photo 16 – lower detention pond

- i. The site's existing two detention basins will be maintained and an additional detention basin will be developed, providing settling and desiltation of run-off prior to entering the conveyance tunnels and from there the cobblefields above the Yuba River.

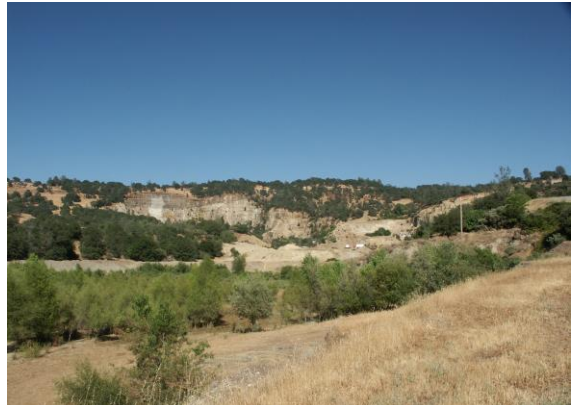
Photo 18 – historic hydraulic escarpment

The site is unique in that the most distinctive geologic feature, the tall escarpment that rises approximately 200' from the valley floor along the east and southern perimeter of the site, is manmade, created by the hydraulic mining that eroded the gold-bearing placer deposits between 1865 and 1885. A large landslide and tension cracks associated with the landslide constitutes what the geotechnical engineering firm of Holdrege and Kull refer to as the site's 'primary geologic hazard' in their Reclamation Plan 99-01, dated January 21, 2002 (Appendix VII) and their 'Geologic Hazards and Post-SMARA Activities' letter dated October 12, 2004 (Appendix VII.) The failure, which consists of 'partially to well cemented cobbles, gravel and sand' that occurred at the contact with the Jurassic aged basalt appears to be in excess of 20 years old, as evidenced by the mature trees growing at the scarp face. Holdrege and Kull report cracks appearing in aerial photographs as early as 1950. The vertical bluffs located north of the failed slope do not appear unstable, and no tension cracks or excessive erosion were observed by Holdrege and Kull at the top or base of their site visit in February 2000. Geotechnical studies performed by Holdrege and Kull indicated an average shear strength of 87 p.s.i. (12,500 p.s.f.) in unconfined compression tests and a factor of safety of approximately 1.2 under static loading and no saturation for the existing vertical slopes. Additionally, on a subsequent site visit in August of 2004, Holdrege and Kull observed that no additional grading or excavation had apparently taken place in the vicinity of the existing bluffs since the enactment of SMARA in 1975. Their recommendations for the bluffs were that in the event of potential future development of the site, geologic setbacks, not greater than the height of the bluffs, be provided and fencing and signs placed at the top of the bluffs to reduce hazards. However, due to the pre-SMARA characteristic of the escarpment and associated slope failure and tension cracks, further consideration of this feature is beyond the scope of this reclamation plan.

The site has a rich mining history, remnants of which remain intact and provide significant historic and cultural value. The existing hydraulicked escarpments, the drainage tunnels, the concrete foundations of pre-SMARA mining equipment and the numerous 'Chinese' stacked stone walls are all resources of value that have been identified and protected by this reclamation plan.
